INSPECTION REPORT: KENSINGTON GOLD MINE

Tongass National Forest Minerals Group
8510 Mendenhall Loop Rd
Juneau, AK 99801
(907) 789-6275– office
(907) 586-8808 – fax

Date of Inspection: Thursday August 24, 2017
Date of Report: Thursday September 7, 2017
USDA Forest Service Inspector: Richard Dudek

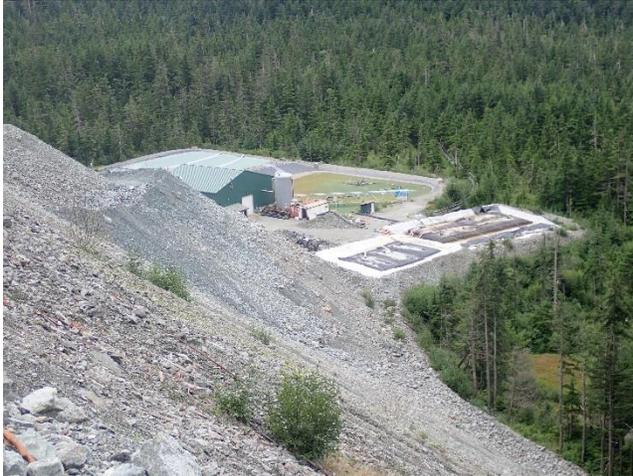
Coeur Alaska continues to stockpile waste rock from the Raven drift at the southern end of the development pile (Photos 1).

Photo 1. The Comet Development Pile.

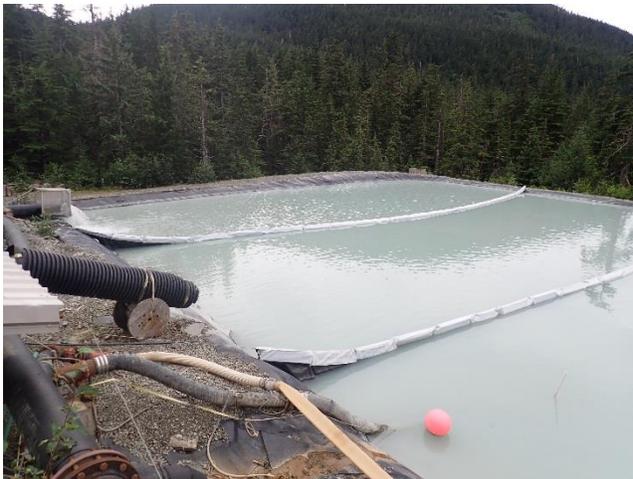
Coeur Alaska personnel recently installed two silt curtains in Pond 1 (Photo 2). The two silt curtains will help minimize the sediment deposition area for the pond. At Pond 2, the dredger was staged and not in operation during the site inspection (Photo 3). The dredging of one settling pond takes three to four weeks.

Photo 2. The two silt curtains installed in Pond 1, and the trash screen was moved to the second inlet pipe.

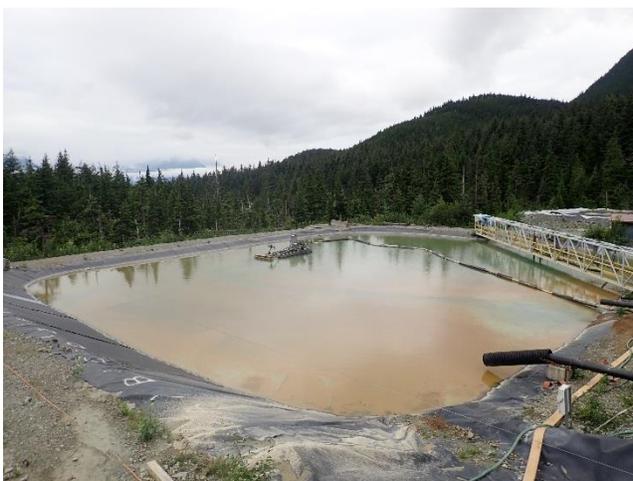
Photo 3. The dredge staged in Pond 2.

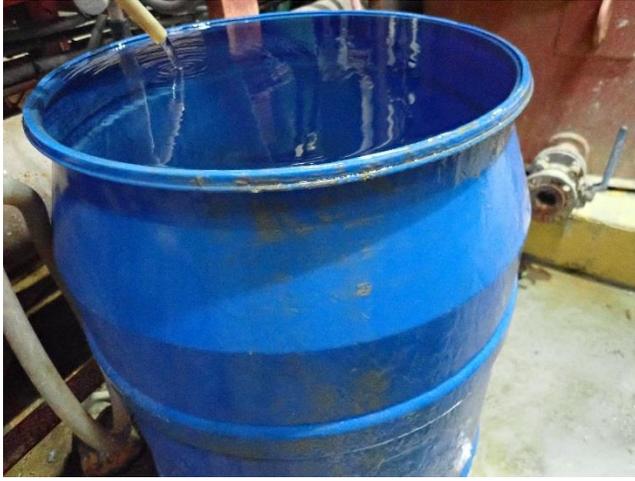
The test barrel for white material accumulation in treated mine site water appeared to have small amounts of a clay like substance around the edge (Photo 4). Although this did not appear to be the “filmy” white material observed during previous inspections. The test barrel should remain in place for temporal monitoring of white material in the discharge of treated mine site water.

Photo 4. The CWTP's test barrel used for monitoring white material accumulation in discharge/treated mine site water.

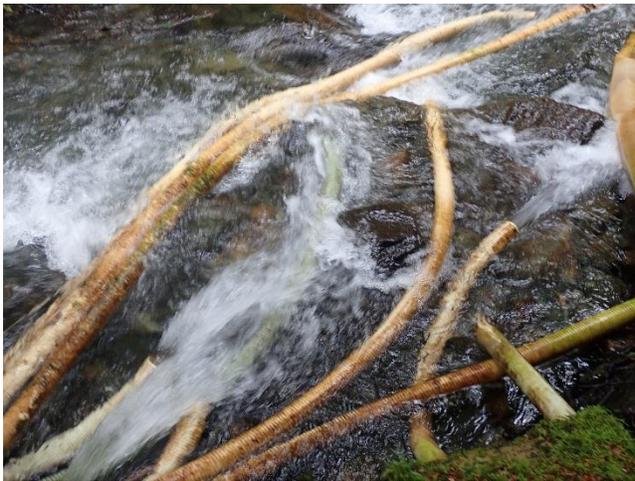
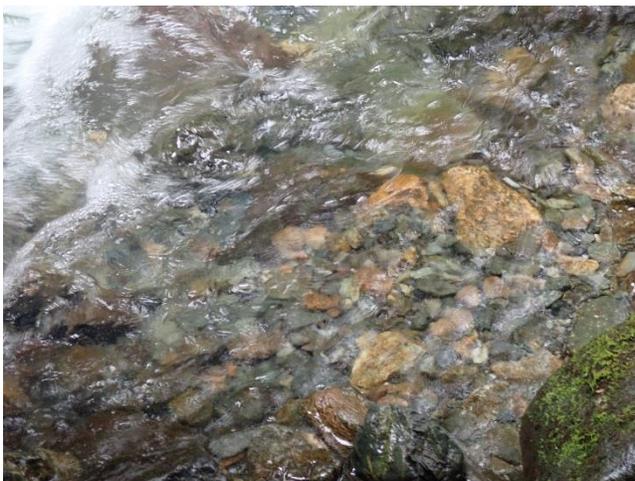
During the site visit, no white material was observed in Sherman Creek (Outfall 001) (Photos 5-6).

Photo 5. Sherman Creek Outfall 001 (Image 1 of 2).

Photo 6. Sherman Creek Outfall 001 (Image 2 of 2).

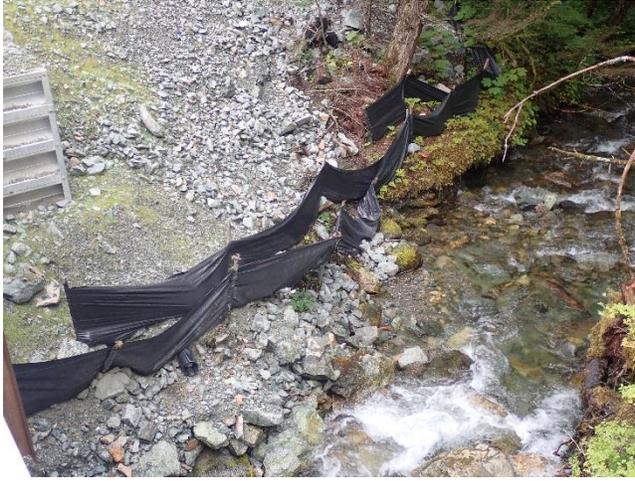
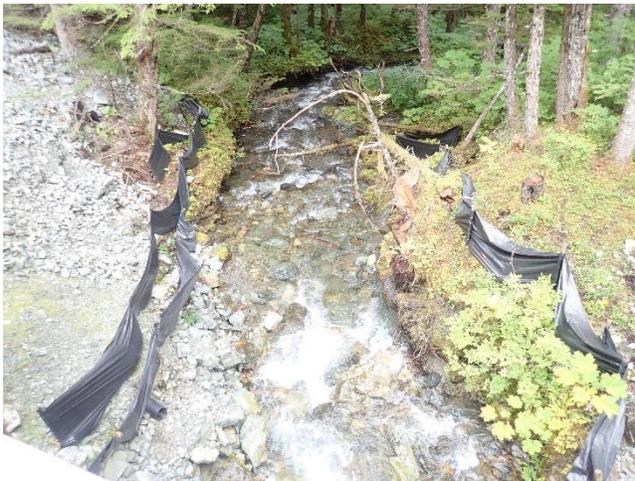
During the previous inspection on 7/27/2017, silt fencing along the bridge abutments required improvements. Since the previous inspection, Coeur Alaska Surface operations have made the necessary improvements to the silt fencing (Photos 7-8). These improvements meet the BMP requirements for slit fencing as stated in Appendix 4g BMP Plan, pages C 10-12.

Photo 7. Silt fencing replacement and maintenance conducted at the abutments for the South Fork Sherman Creek Bridge (Image 1 of 2).

Photo 8. The South Fork Sherman Creek Bridge abutments silt fencing.

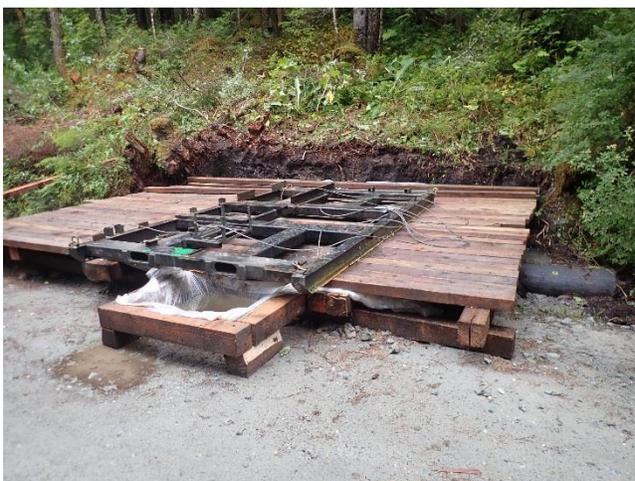
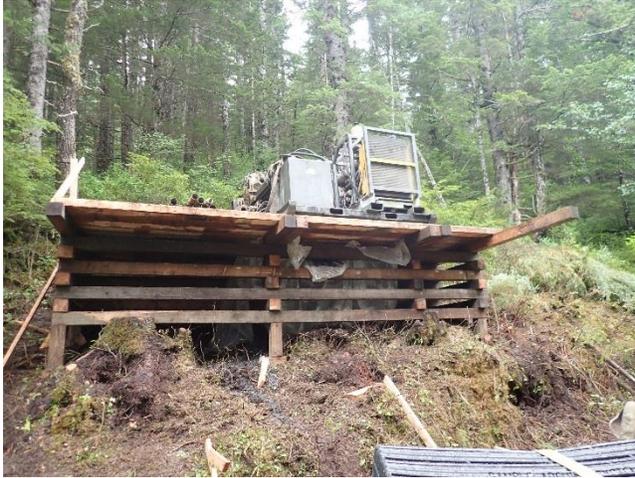
Geo-technical drill pads have been constructed at this location (Photos 9-10).

Photo 9. One of two constructed geotechnical drill pad located in the vicinity of Comet Beach (Image 1 or 2).

Photo 10. The second constructed geotechnical drill pad in the Comet area (Image 2 of 2).

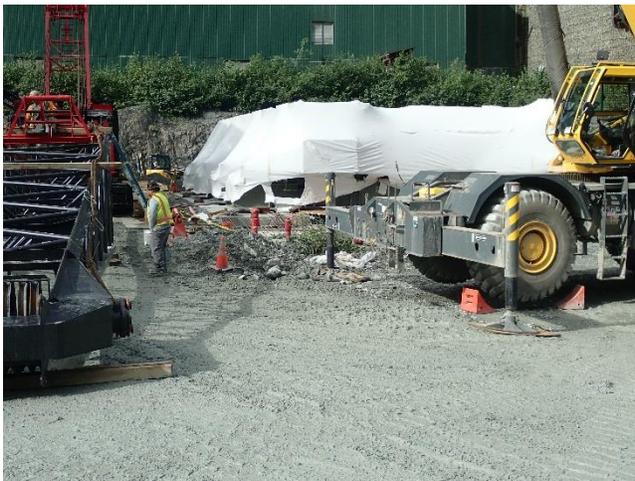
The four new 4-megawatt (MW) generators are now staged, and construction continues for the powerhouse, 30,000-gallon day tank cover, and the refueling pad (Photo 11). These generators will supply power to the mine site.

Photo 11. The four new 4-MW generators staged at the mill area.

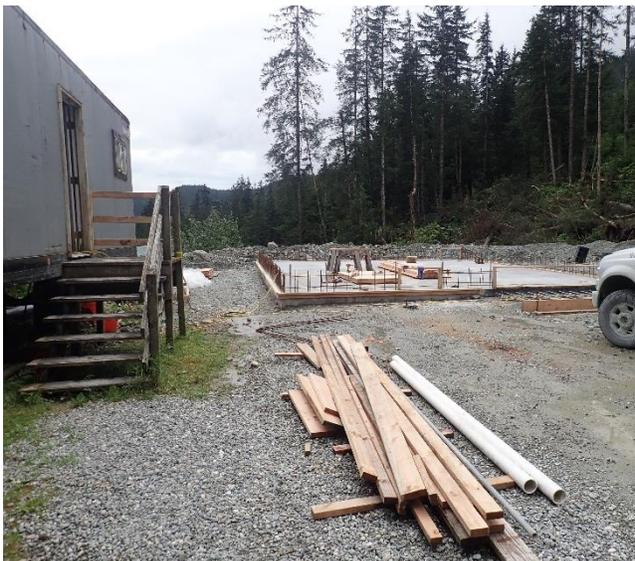
The concrete foundation for the carpenters shop is completed (Photo 12), and contractors continue the construction for the new shop.

Photo 12. The new carpenter shop.

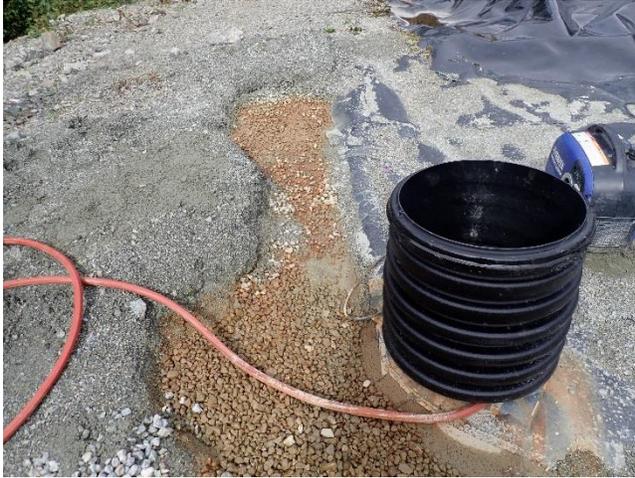
Coeur Alaska Surface operations installed a drain to remove water that collected underneath the edge of a graphitic phyllite (GP) stockpile’s HDPE liner (Photo 13). Coeur personnel will continue to monitor the area, and if no more water reports to the edge, more than likely a hole was the cause of the water accumulation.

Photo 13. The drain installed for the Mud Dump's HDPE liner.

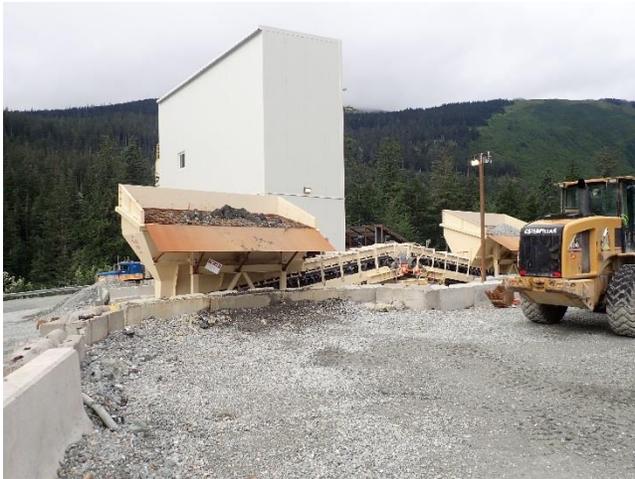
The Pug plant (Photo 14) is currently offline and in need of repairs. Once the repairs are made, Coeur Alaska will continue using the facility for making GP/cement underground backfill. Some of the GP material that is currently staged (Photo 15) near the pug plant is from Pit 7, and is located in the same place the “temporary” GP stockpile was located at Pit 4.

Photo 14. The Pug plant at Pit 4.

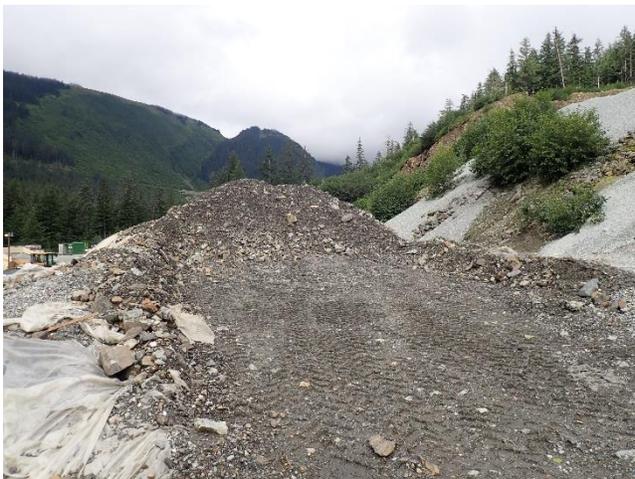
Photo 15. GP material from Pit 7 is stockpiled at Pit 4.

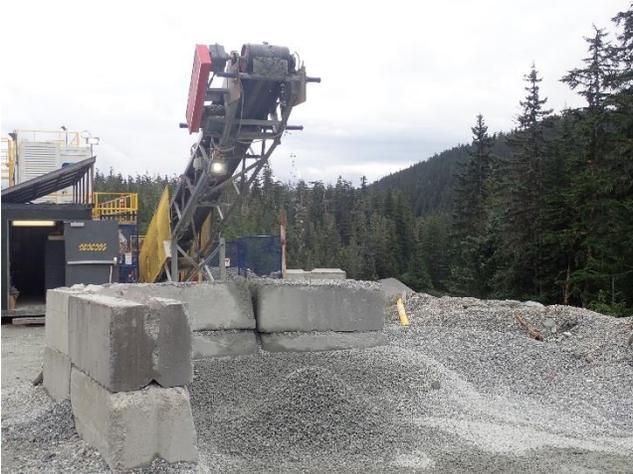
Approximately 30,579 tons of pebble rock has run through the x-ray sorter (Photo 16), with approximately 3,631 tons of pebble rock reclaimed and sent back to the mill.

Photo 16. The x-ray sorter.

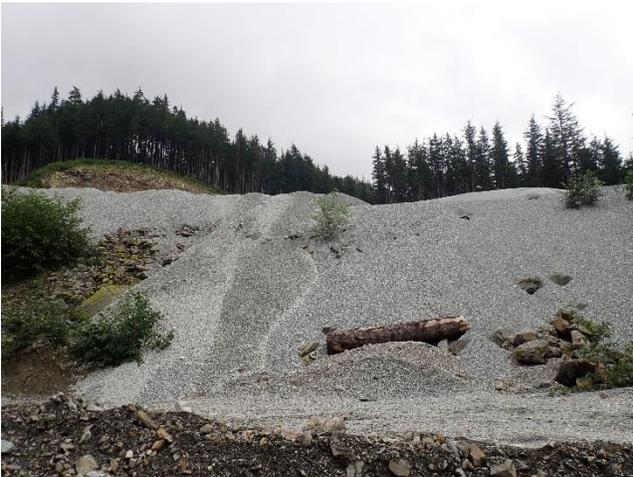
Coeur personnel continue to relocate/stockpile x-ray reject pebble rock near the pug plant (Photos 17). Some of the reject pebble rock will be utilized as an aggregate for the GP cement mix.

Photo 17. A pebble rock stockpile at Pit 4. This stockpile will be utilized as an aggregate for GP/cement mix.

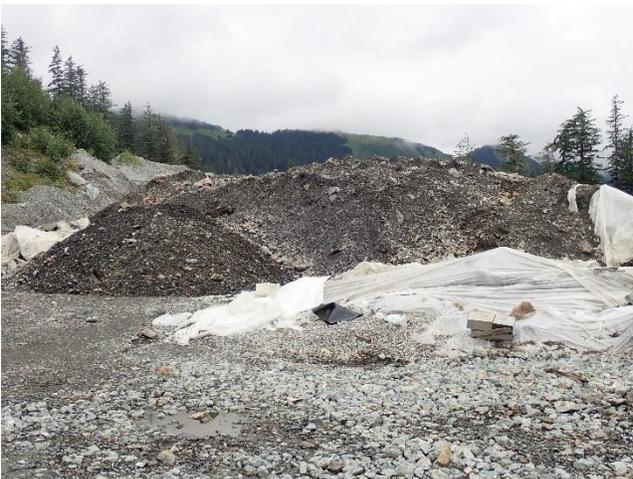
Photo 18. The GP stockpile at Pit 7.

Coeur Alaska is currently utilizing the GP material (Photo 18) from this location for GP/cement underground backfill. It is recommended that the stockpile is fully covered when not in use.

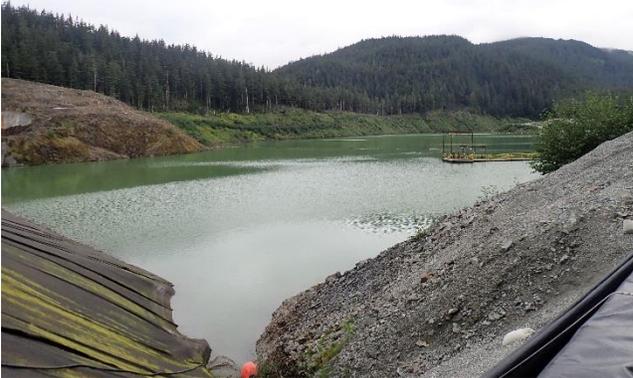
At the time of the inspection, the TTF’s water level was 696.85 feet (Photo 19), and the water treatment plant (Photo 20) was discharging at 750 gpm.

Photo 19. The TTF.

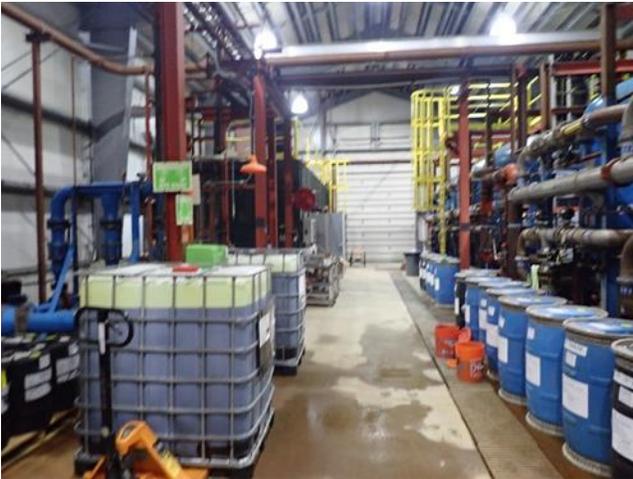
Photo 20. The TTF water treatment plant.

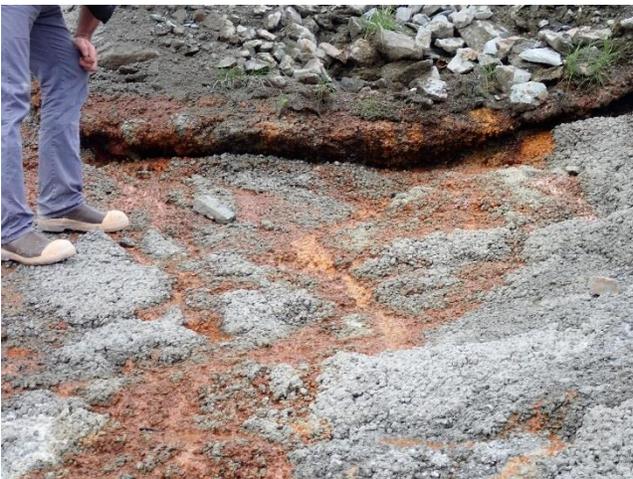
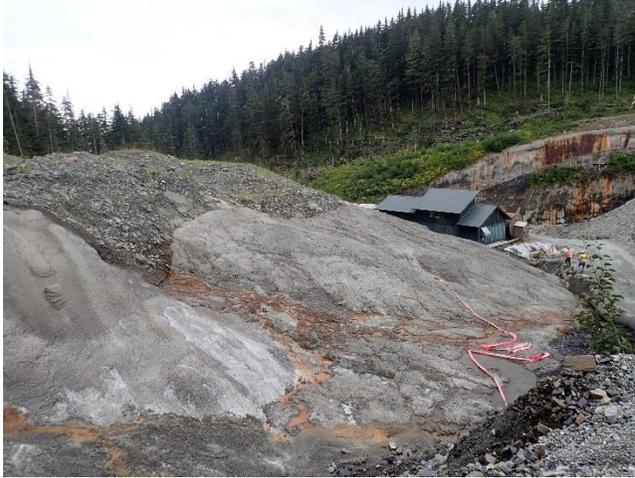
A concrete cover was recently applied to a GP outcrop located at the east abutment of the dam (Photo 21-22). During this inspection, ARD was observed flowing from an exposed section of the outcrop and downgradient into an ARD drainage ditch. The ARD that is collected is routed to the TTF back pump, and then back into the TTF. Additional site investigations will need to be made in order to determine if additional mitigations need to be implemented. Coeur Alaska Environmental operations are aware of the ARD seepage and contacted Surface operations for implementing additional mitigations at this site.

Photo 21. ARD seepage at the east abutment of the TTF dam.

Photo 22. The ARD seepage is diverted into a drainage ditch.

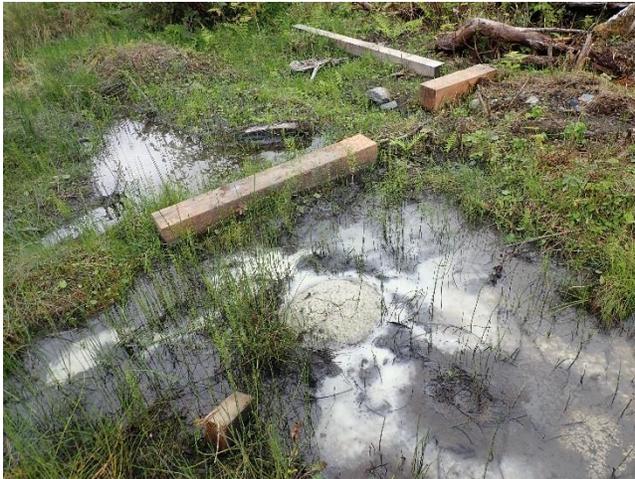
Located in the northern TTF area, the geo-technical drilling borehole “BH-006” was reclaimed or “plugged”, (Photo 23) and only unusable drill pad timbers remain which will be eventually removed from this location. The borehole plugging is a concurrent reclamation requirement that is stated in the 2017 Surface Exploration Annual Work Plan’s Decision Memorandum.

Photo 23. Geotechnical borehole "BH-006" reclaimed or "plugged".

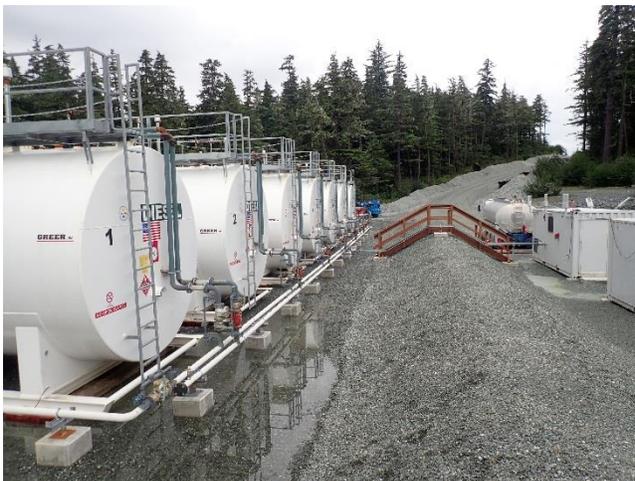
This location was tidy and in order (Photo 24).

Photo 24. The fuel depot.
